Manhole Inspection Summary

Manhole # S21K__024MH

Location Address: **1903 s monroe-goldsmith alley**

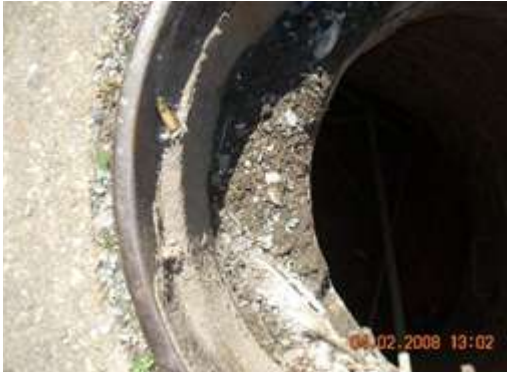
Defect 1

Frame Offset: **0** (in.) Condition: ☒ Sound ☐ Cracked ☐ Leaks

frame offset

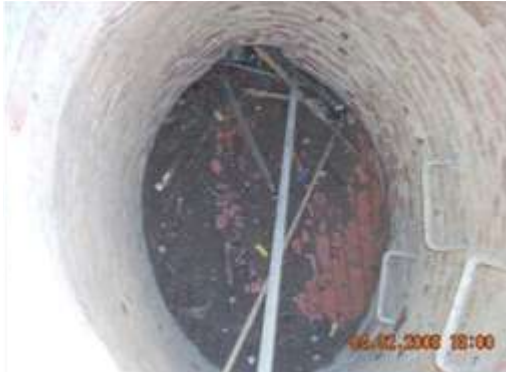
Defect 2

Condition: ☐ Sound ☐ Cracked ☐ Root Intrusion ☐ Deteriorated ☐ Leaks ☒ **Debris**

channel cond debris

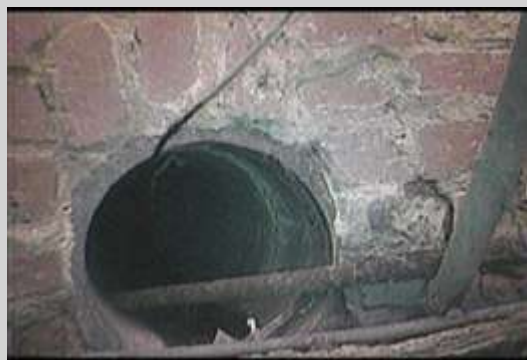
12 O'Clock Outflow

channel debris

Deposits: ☐ None ☐ Mud ☐ Sludge ☒ **Debris** ☐ Grease

Silt Depth: **2** (in.) Deposits Extent: **Light**
